**Flood Control Project Maintenance  
Levee Inspections**

## Maintenance Issue Types Only, Levee Inspection Report By Mile - Spring 2019

### Reclamation District No. 2103 Wheatland Vicinity

Waterway	Bank	Unit Miles	Inspection Start/End	Inspector
Unit No. 01 South Dry Creek	Left	4.64	04/03/2019 04/03/2019	Sterling York

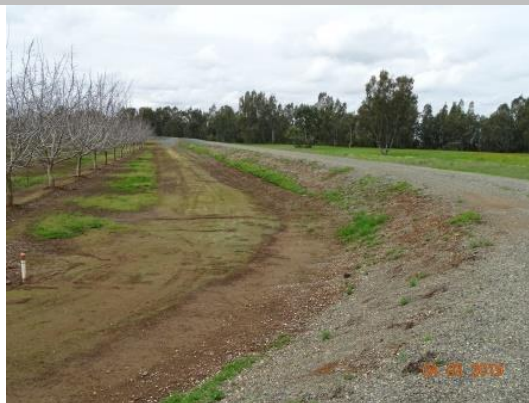
Photo 1 of 1 : SP\_2019\_RD2103\_10\_19\_20190409\_00042.jpg

LM Start	0.00	Rating **	A	Issue No.	19
LM End	4.52	Issue Type +	Ma	Location *	LS
Category	Earthen Levee			GPS Latitude/Longitude	
				Start	End
Item	Vegetation			39.019794 °	39.042188 °
				-121.454006 °	-121.393576 °
DWR ID	DWR_RD2103_01_s_2019_19				
Comment Code					
V1 : Control annual grass and weeds on the levee slopes and easements.					
Inspector Comment					
The annual vegetation is well maintained, Spring 2019.

View looking downstream landside at the well maintained annual vegetation, Spring 2019.

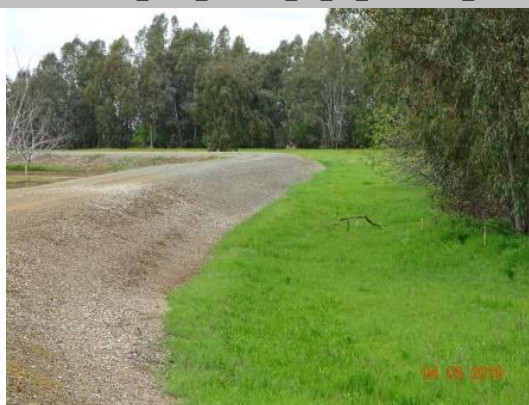
Photo 1 of 1 : SP\_2019\_RD2103\_10\_20\_20190409\_00041.jpg

LM Start	0.00	Rating **	A	Issue No.	20
LM End	4.52	Issue Type +	Ma	Location *	WS
Category	Earthen Levee			GPS Latitude/Longitude	
				Start	End
Item	Vegetation			39.019794 °	39.042188 °
				-121.454006 °	-121.393576 °
DWR ID	DWR_RD2103_01_s_2019_20				
Comment Code					
V1 : Control annual grass and weeds on the levee slopes and easements.					
Inspector Comment					
The annual vegetation is well maintained, Spring 2019.

View looking downstream waterside at the well maintained annual vegetation, Spring 2019.

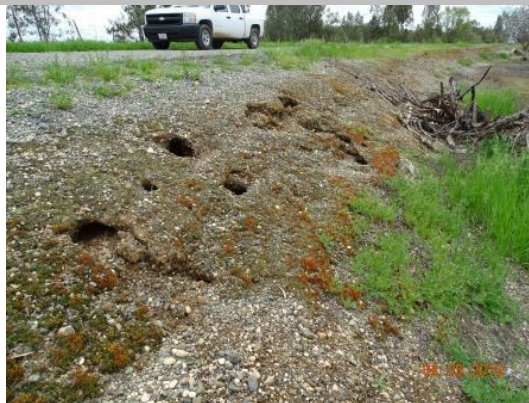
Photo 1 of 1 : SP\_2019\_RD2103\_10\_18\_20190409\_00040.jpg

LM Start	0.06	Rating **	M	Issue No.	18
LM End	0.06	Issue Type +	Ma	Location *	LS
Category	Earthen Levee			GPS Latitude/Longitude	
				Start	End
Item	Animal Control			39.020173 °	39.020173 °
				-121.453003 °	-121.453003 °
DWR ID	DWR_RD2103_01_s_2019_18				
Comment Code					
A3 : No rodents visible, but rodent burrows visible; need to backfill and compact or grout burrows.					
Inspector Comment					
Rodent holes in the levee slope need to be backfilled, Spring 2019.

View of squirrel holes on the landside looking downstream but no evidence of animal activity during Spring 2019 inspection.

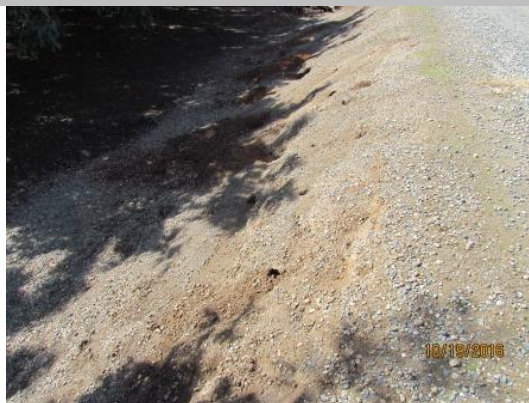
Photo 1 of 1 : SP\_2019\_RD2103\_10\_23\_20190305\_00003.jpg

LM Start	0.20	Rating **	M	Issue No.	23
LM End	0.22	Issue Type +	Ma	Location *	LS
Category	Earthen Levee			GPS Latitude/Longitude	
				Start	End
Item	Animal Control			39.020856 °	39.020938 °
				-121.450629 °	-121.450237 °
DWR ID	DWR_RD2103_01_f_2015_23				
Comment Code					
A3 : No rodents visible, but rodent burrows visible; need to backfill and compact or grout burrows.					
Inspector Comment					
Rodent holes in the levee slope need to be backfilled.

View of squirrel holes on the waterside looking downstream but no evidence of animal activity.

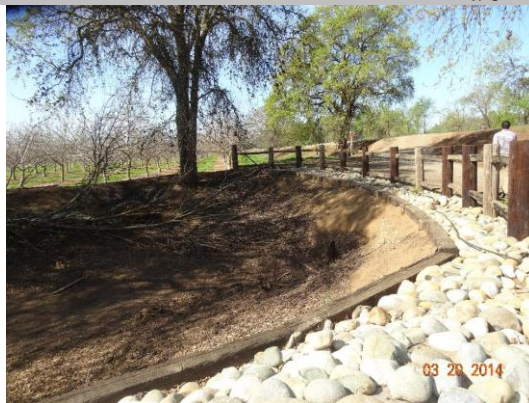
Photo 1 of 3 : UCIP\_SP\_2019\_38325\_69869.jpg

LM Start	0.82	Rating **	A/W	Issue No.	36
LM End	0.82	Issue Type +	Ma	Location *	
Category	Supplemental			GPS Latitude/Longitude	
				Start	End
Item	DWR UCIP LMA Responsibility			39.024811 °	39.024811 °
				-121.440750 °	-121.440750 °
DWR ID	19471				
Comment Code					
Inspector Comment					
FS_ID:38325 DS_ID:19471 EP_NO: N/A Repair Type: No Action Needed Crossing Status: Found UCIP Comments: FIELD_STRUCT_DESC: 36-inch corrugated metal drainage pipe through the levee, 14.4 feet below the crown. Concrete headwall, flap-gate, and 3-foot by 6-foot concrete splash apron located on the waterside (WS) toe. Outfall drain from old Grasshopper Slough. [Additional Reference(s): DWR Levee Logs, 2005. USACE Sacramento O&M Manual Unit No. 146, November 1962, (HLM 0.83)] FS Date: 3/20/2014

View of CMP crossing located on landward side.

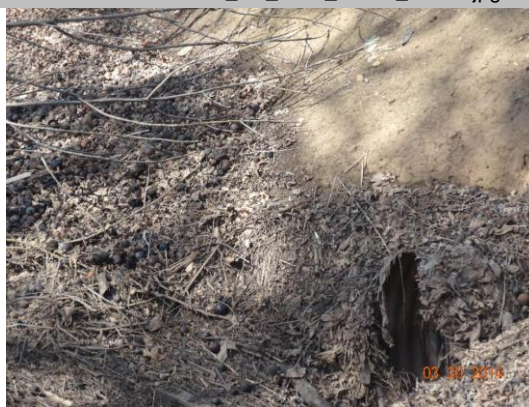
Photo 2 of 3 : UCIP\_SP\_2019\_38325\_69868.jpg

Close up view of crossing from landward side.

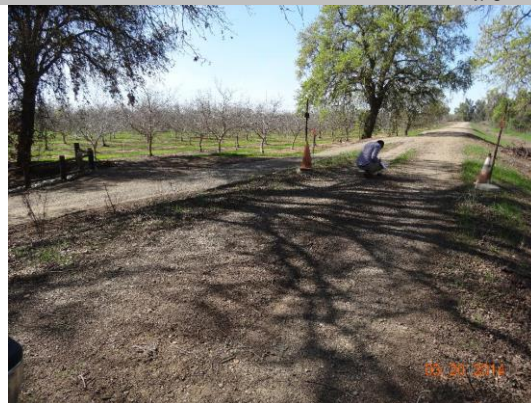
Photo 3 of 3 : UCIP\_SP\_2019\_38325\_69873.jpg

LM Start	0.82	Rating **	A/W	Issue No.	36 (cont)	
LM End	0.82	Issue Type +	Ma	Location *		
Category	Supplemental			GPS Latitude/Longitude		
				Start	End	
Item	DWR UCIP LMA Responsibility			39.024811 °	39.024811 °	
				-121.440750 °	-121.440750 °	
DWR ID	19471					
Comment Code						
Inspector Comment						
FS_ID:38325 DS_ID:19471 EP_NO: N/A Repair Type: No Action Needed Crossing Status: Found UCIP Comments: FIELD_STRUCT_DESC: 36-inch corrugated metal drainage pipe through the levee, 14.4 feet below the crown. Concrete headwall, flap-gate, and 3-foot by 6-foot concrete splash apron located on the waterside (WS) toe. Outfall drain from old Grasshopper Slough. [Additional Reference(s): DWR Levee Logs, 2005. USACE Sacramento O&M Manual Unit No. 146, November 1962, (HLM 0.83)] FS Date: 3/20/2014

View of levee crown at crossing.

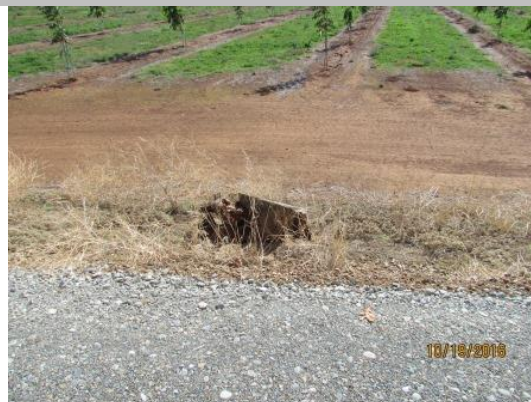
Photo 1 of 1 : SP\_2019\_RD2103\_10\_26\_20190305\_00004.jpg

LM Start	1.27	Rating **	N	Issue No.	26
LM End	1.27	Issue Type +	Ma	Location *	LS
Category	Earthen Levee			GPS Latitude/Longitude	
				Start	End
Item	Trim / Thin Trees			39.027261 °	39.027261 °
				-121.433269 °	-121.433269 °
DWR ID	DWR_RD2103_01_s_2016_26				
Comment Code					
T5 : Tree stumps.					
Inspector Comment					
Stump needs to be removed fom slope.

View of tree stump on landside levee slope. Fall 2016, still exist as of Fall 2018.

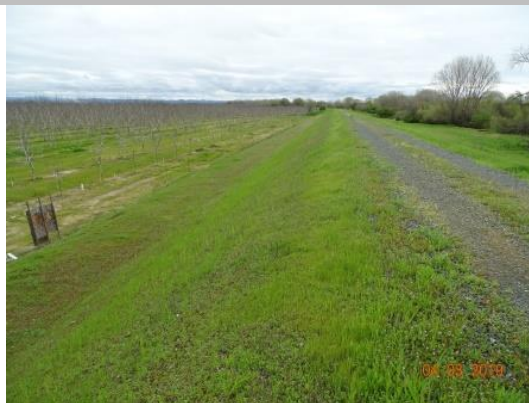
Photo 1 of 1 : SP\_2019\_RD2103\_11\_11\_20190409\_00032.jpg

LM Start	0.02	Rating **	A	Issue No.	11
LM End	4.88	Issue Type +	Ma	Location *	LS
Category	Earthen Levee			GPS Latitude/Longitude	
				Start	End
Item	Vegetation			38.993502 °	39.031761 °
				-121.437016 °	-121.366800 °
DWR ID	DWR_RD2103_02_s_2019_11				
Comment Code					
V1 : Control annual grass and weeds on the levee slopes and easements.					
Inspector Comment					
The annual vegetation is well maintained, Spring 2019.

View looking upstream landside at the well maintained annual vegetation, Spring 2019.

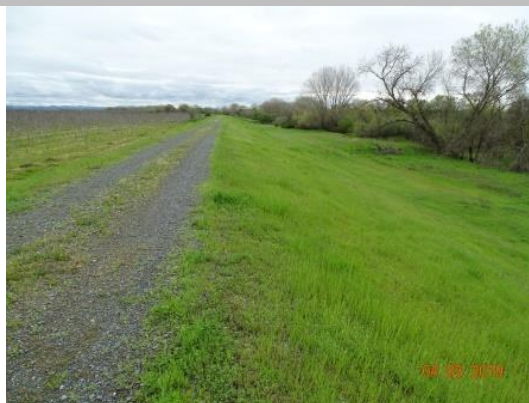
Photo 1 of 1 : SP\_2019\_RD2103\_11\_13\_20190409\_00033.jpg

LM Start	0.02	Rating **	A	Issue No.	13
LM End	4.88	Issue Type +	Ma	Location *	WS
Category	Earthen Levee			GPS Latitude/Longitude	
				Start	End
Item	Vegetation			38.993502 °	39.031761 °
				-121.437016 °	-121.366800 °
DWR ID	DWR_RD2103_02_s_2019_13				
Comment Code					
V1 : Control annual grass and weeds on the levee slopes and easements.					
Inspector Comment					
The annual vegetation is well maintained, Spring 2019.

View looking upstream waterside at the well maintained annual vegetation, Spring 2019.

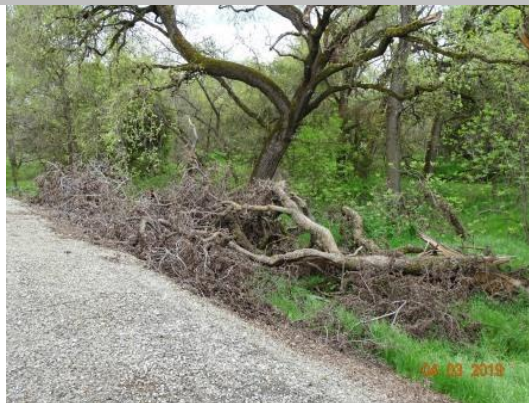
Photo 1 of 1 : SP\_2019\_RD2103\_11\_14\_20190409\_00034.jpg

LM Start	1.86	Rating **	M	Issue No.	14
LM End	1.86	Issue Type +	Ma	Location *	WS
Category	Earthen Levee			GPS Latitude/Longitude	
				Start	End
Item	Encroachments			39.001644 °	39.001644 °
				-121.405450 °	-121.405450 °
DWR ID	DWR_RD2103_02_s_2019_14				
Comment Code					
TR : Tree or limb					
Inspector Comment					
Remove downed tree from levee slope, Spring 2019.

View looking upstream waterside at a downed tree on the levee slope, Spring 2019.
